New York City Transit

Re Final Report, Derailment, S/O 65th Street, Queens Line

Office of System Safety Derailment Report

S/O 65th Street, Track D3

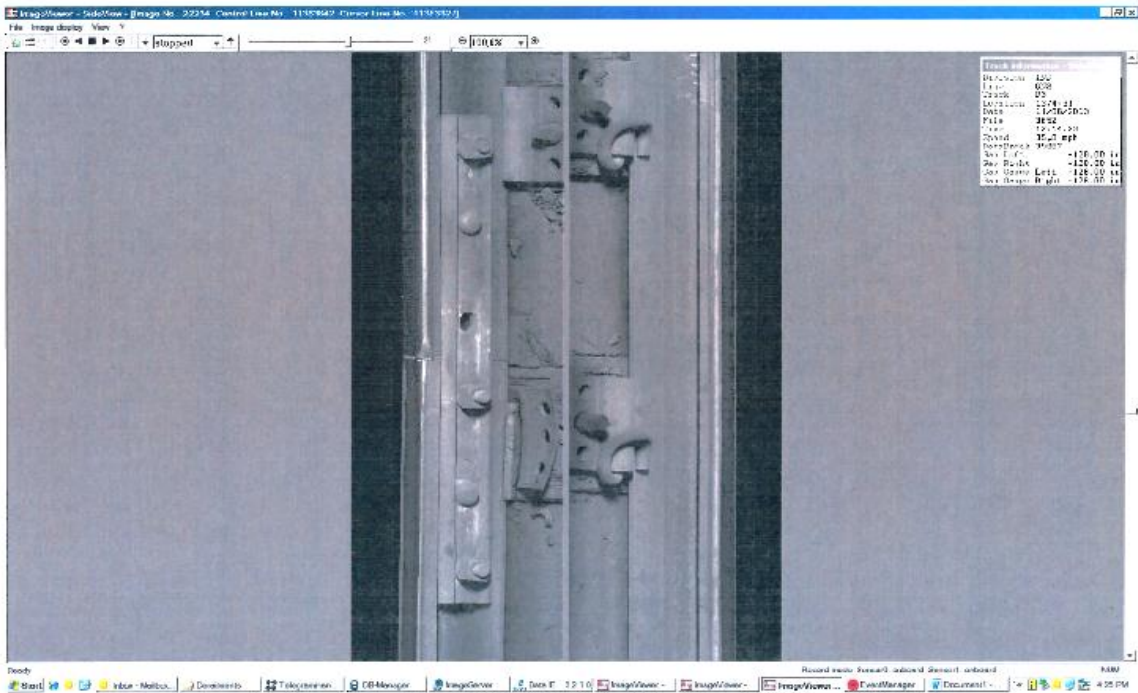
- A review of video data captured during earlier TGC4 runs reflect that the plate at the POD had been broken for at least one year prior to the derailment. In addition, the condition of the tie under the sheared plate was poor.

- The distance between the center of the joint and the first non-defective fastener under the rail joint was approximately equal to 25 inches; therefore, this condition (joint support failure) should have been classified as a P2 defect condition as per MW-1 Standards Table 108.3-Crosstie and Fastening Requirements.

Gauge Side View of Rail Joint and broken plate at POD – TGC4 Video of 11/08/2013

Gauge Side View of Rail Joint and broken plate at POD – TGC4 Video 11/8/2013

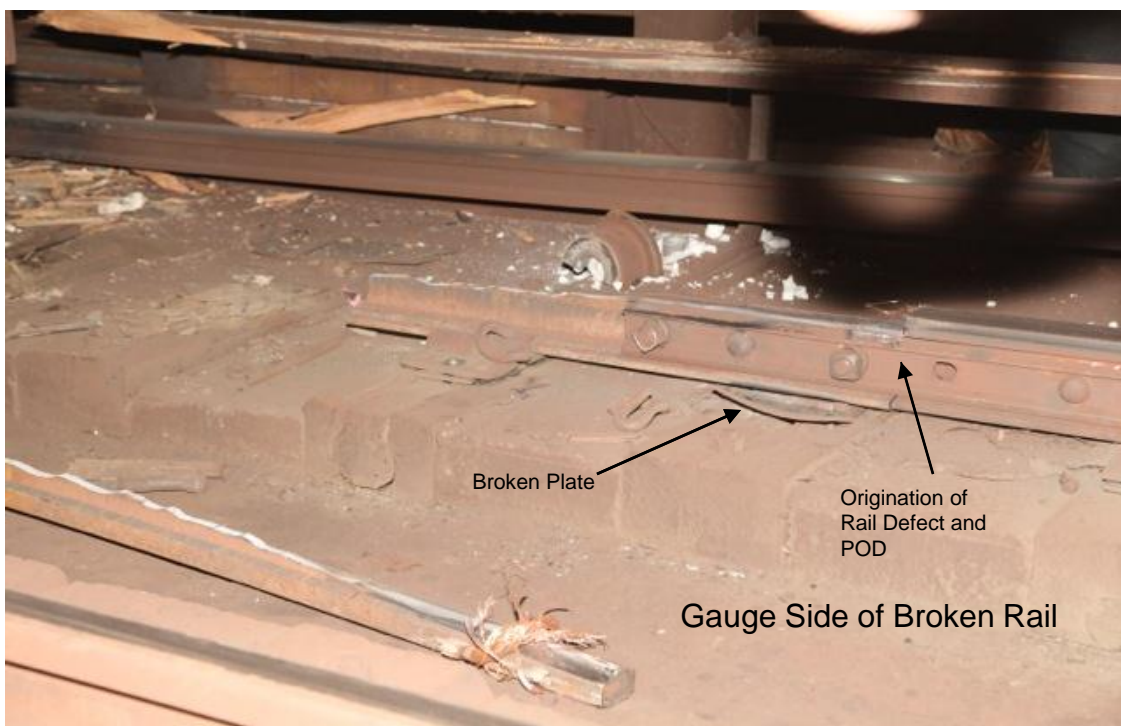
- The uncorrected P2 defect at D3 1374+60 was determined to be the primary causal factor leading to the broken rail that resulted in the derailment. The first plate under the rail joint intended to support the new 19 foot, 6 inch rail installed on February 8, 2014 was sheared on the gauge side of the track, offering no support for vertical and lateral movement of the rail joint under load.

Post Incident View of Fractured Rail and Unsupported Rail Joint

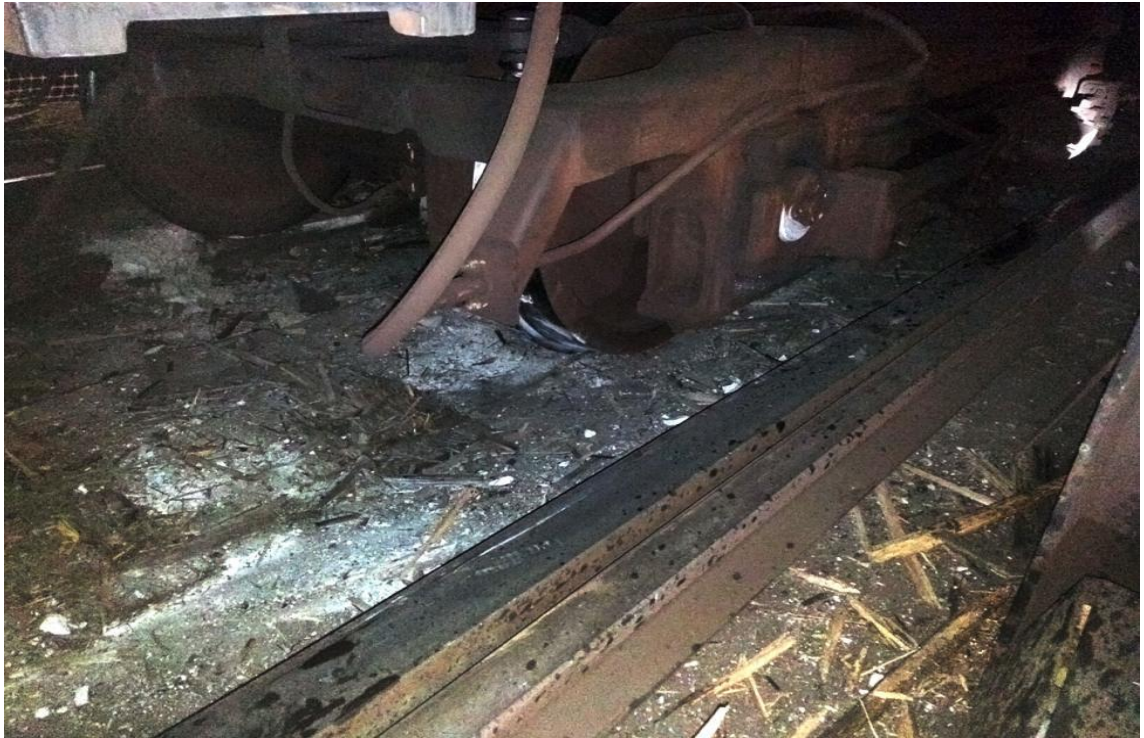
Extensive Damage to Track D3

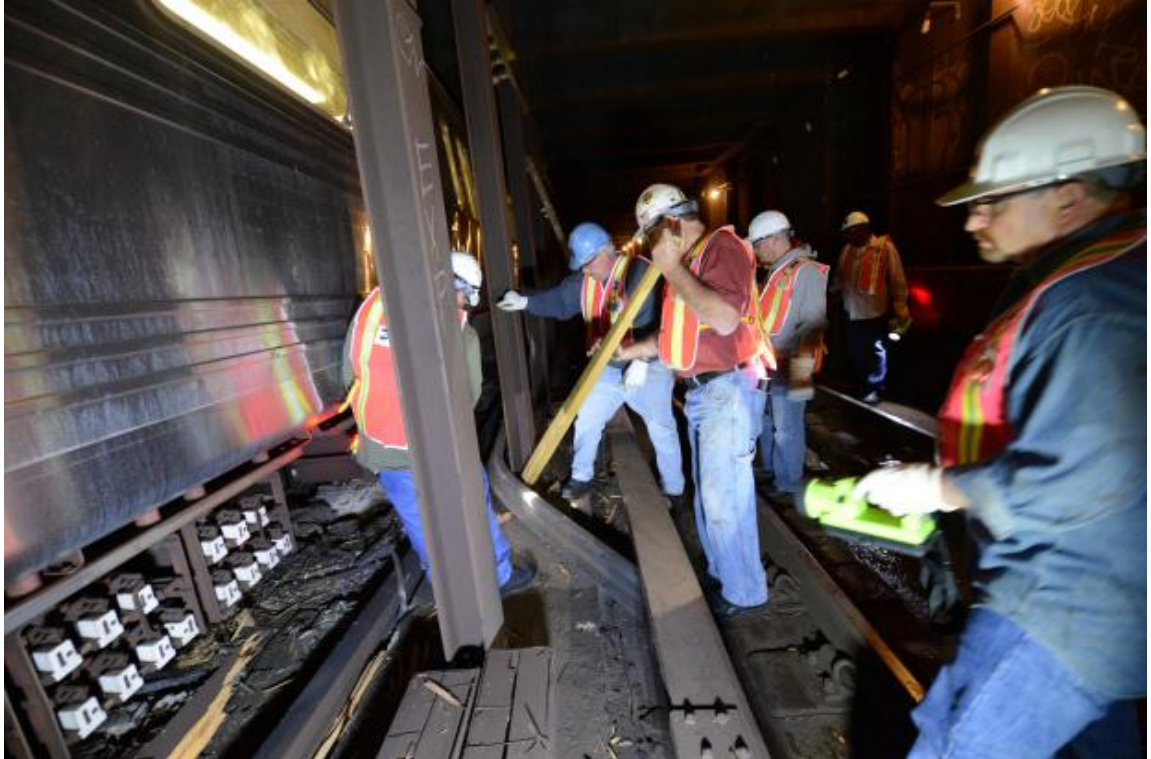
A section of the broken west rail bowed outward and collided with the energized contact rails of both Track D1 and D3 causing an explosion and the fusing of these components, which resulted in the subsequent smoke condition in the area. The circuit breakers feeding the contact rails opened due to an overload condition, which removed power from the contact rails on Tracks D1 and D3.

Removal of Running Rail from Track D3 bent towards and contacting 3rd Rail on Track D1
