New York City Transit

Re Final Report, Derailment, S/O 65th Street, Queens Line

Office of System Safety Derailment Report

S/O 65th Street, Track D3

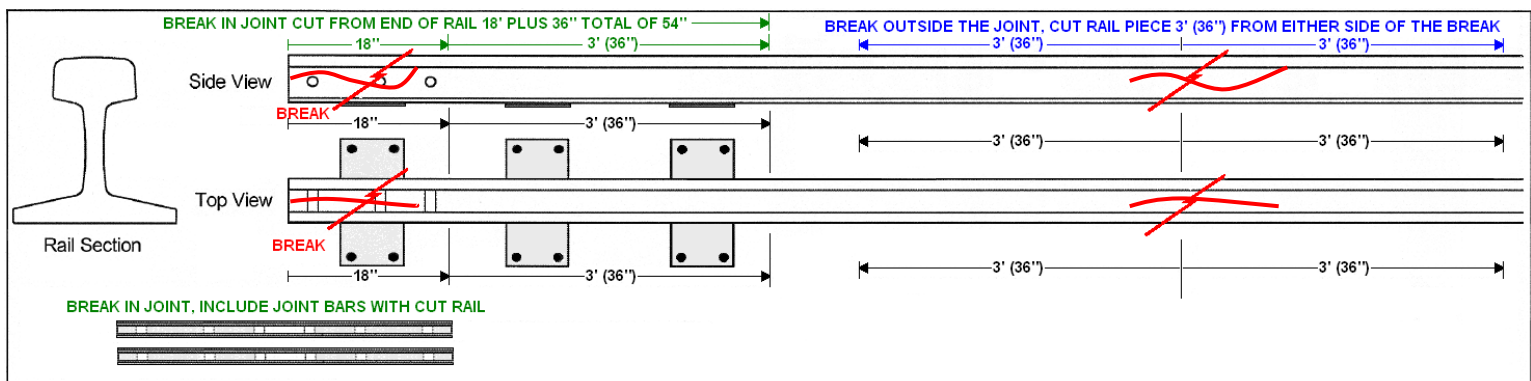
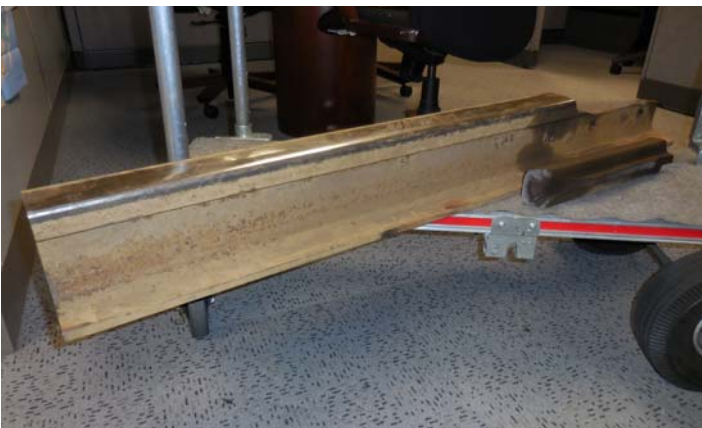
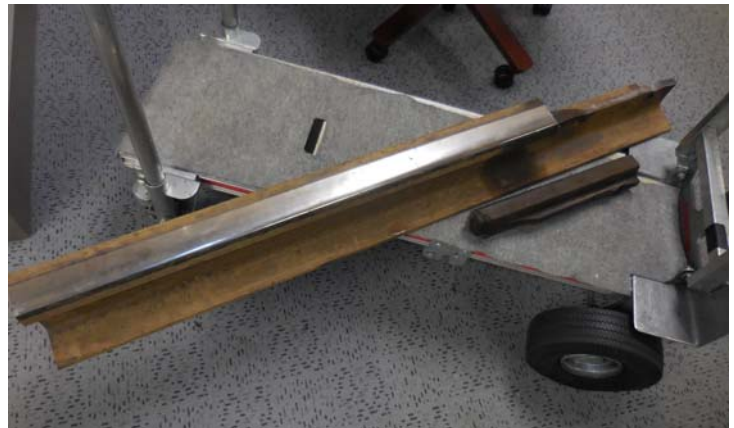
All in-service broken rails that are caused by a head-web separation, or a horizontally split web (similar to the ones that occurred S/O 65th St. on track D3 and S/O DeKalb Ave. on track Q2 recently), are cut at the site in such a way that the joint bars and a minimum of 3 ft. of the adjoining rail (in case of the break occurring at a joint) on each side of the break are preserved. In addition, pictures must be taken showing the configuration of the break in the track location, as found before any repairs were made or the rail disturbed.

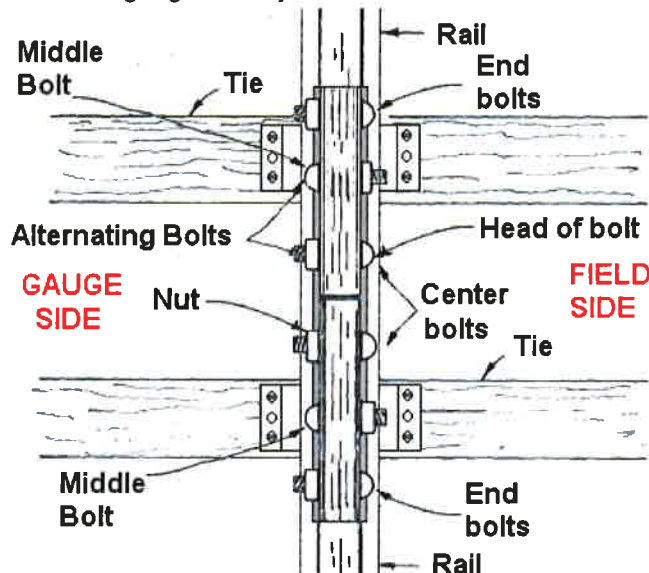
Alternating Bolt Pattern

- ❖ Each six hole G-bar joint shall have the bolts with alternating head positions starting with the two center bolts, which must have their bolt heads to the field side of the joint bar, as well as the bolts at each end of the six holes G-Bar facing to the field side of the joint bar. The middle bolts (between the center bolt and end bolt) must have their bolt heads towards the gauge of the joint bar.

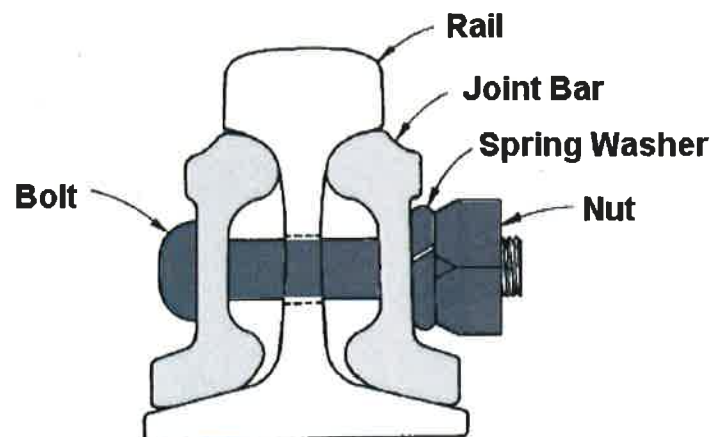
Proper Bolt Installation

- ❖ It is absolutely essential that G-bars be properly seated and all six track bolts must be tightened to compress the spring washer between the nut and the joint bar. This will reduce rail end batter, joint bar stress, broken bolts and bars.
- ❖ **When installing new rails, the surfaces of the joint bars that would be in contact with the surface of the running rail shall be examined for any burrs, sharp edges or other imperfections that could cause a concentration of stress points on the running rail; if this is the case the joint bar shall be replaced with a new one, or ground accordingly to assure a proper good fit.**
- ❖ Avoid striking the G-bar when installing rail hold down spikes or Pandrol clips.

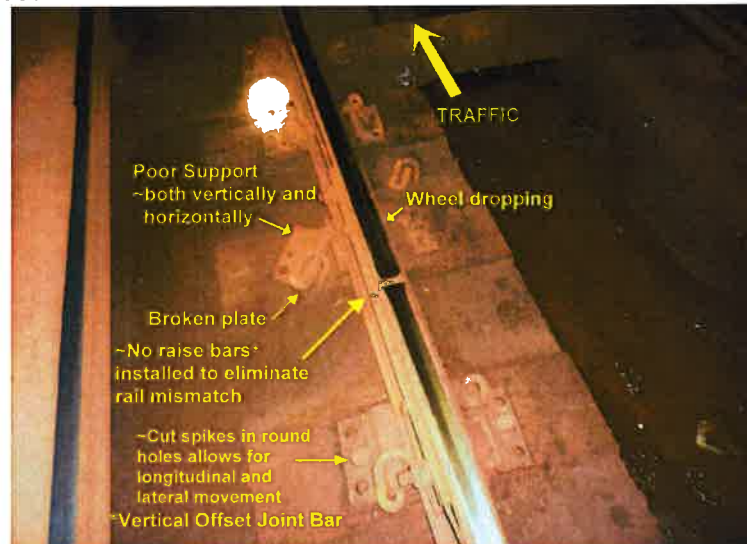
- ❖ Broken plates under a rail joints are a major concern for the integrity and longevity of the rail joint. Timely corrective action as described in the MW-1 is absolutely essential to prevent joint failure and battered running rails. **Broken fasteners under the receiving end (in the direction of traffic) of the running rail at a joint shall be replaced as soon as possible;** in addition, if there are signs of movement, either vertically, laterally or both at the joint, this condition shall be classified as a Priority 2, requiring that a slow speed shall be posted at the location until the broken fastener is replaced.

- ❖ Any broken tie plate must be replaced and the tie repaired and plate properly shimmed when you overhaul any rail joint as per the MW-1.
- ❖ When a rail joint is opened for maintenance, the joint bars must be inspected and cleaned; the rail in the joint area and the contact surfaces of the joint bar shall be cleaned (wire brushed) to remove any debris.
- ❖ Vertical Offset Bars (a/k/a: raise bars) must be used to adjust the in-service joints to worn rail when installing a new running rail. This will preserve the new rail and inhibit rail end batter, and prevent wheel dropping on the trailing end of the joint which prevents rail head flattening and broken joint bars. Vertical Offset Bars comes in various rise sizes; 1/16", 1/8", 1/4", and 3/8".
